**RADIOLOGICAL CHARACTERIZATION REPORT FOR
FUSRAP PROPERTIES IN THE ST. LOUIS, MISSOURI, AREA**

VOLUME I

MARCH 1990

**K. C. Noey
C. M. Sekula
Bechtel National, Inc.
Oak Ridge, Tennessee**

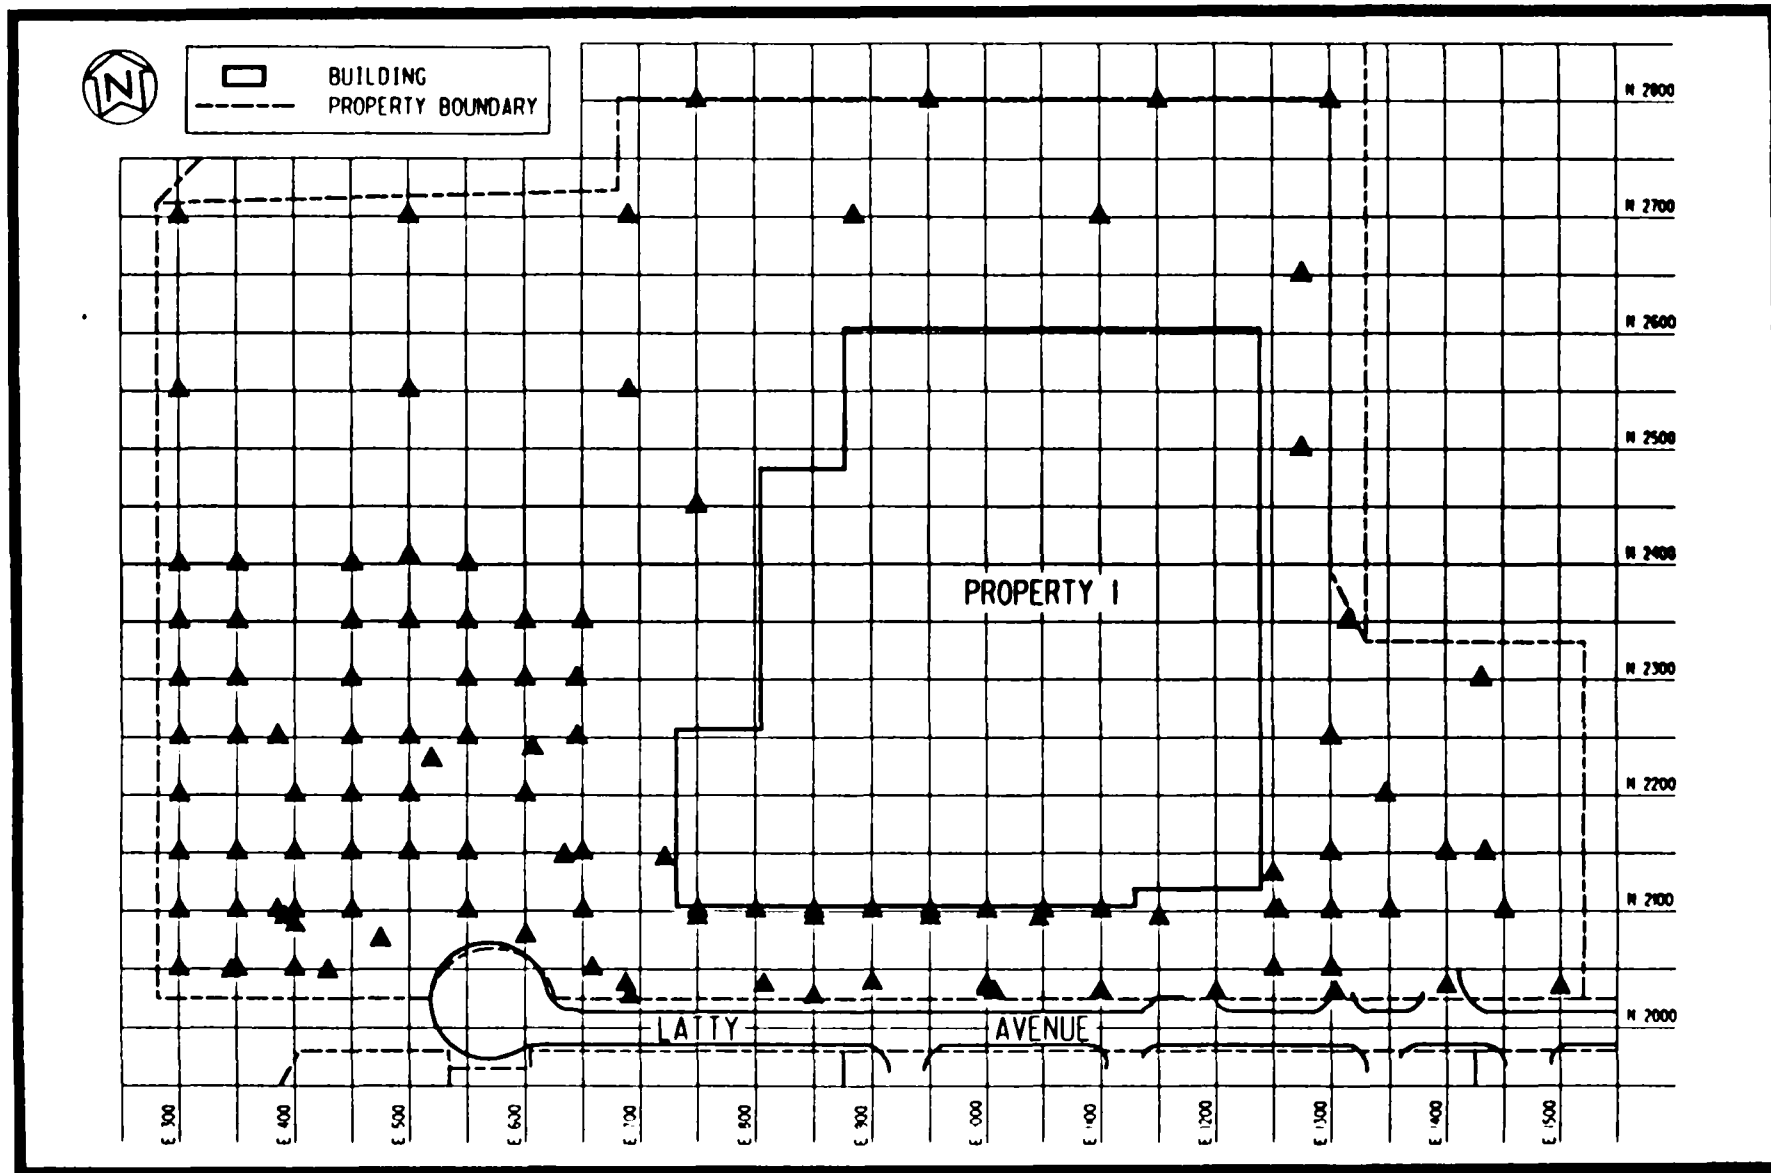
FIGURE 3-1 SURFACE SOIL SAMPLING LOCATIONS FOR RADIOLOGICAL CHARACTERIZATION OF PROPERTY 1 ON LATTY AVENUE

Soil sampling locations on Property 1 are shown in Figures 3-1 and 3-2. Analytical results for soil (Table 3-2) revealed areas with elevated concentrations of radium-226 and thorium-230 in surface and

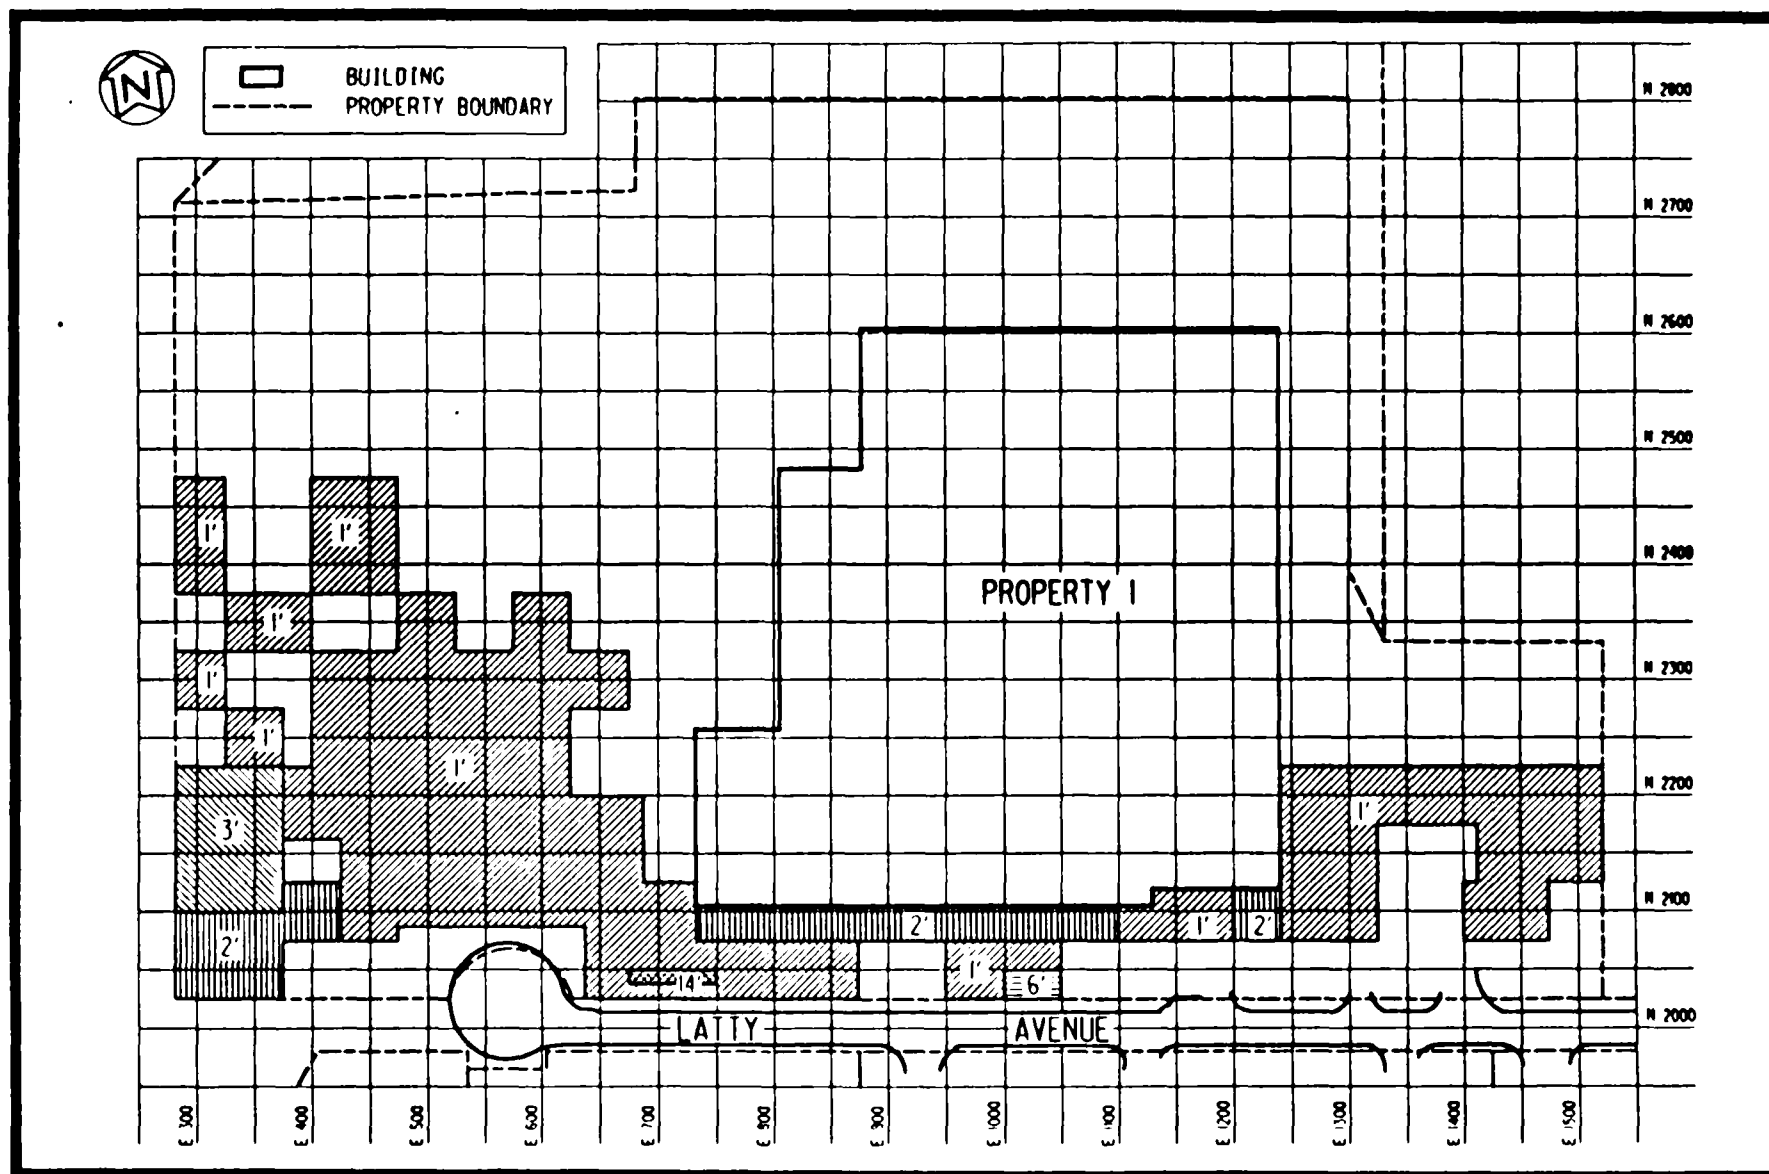
FIGURE 3-3 AREAS AND DEPTHS OF RADIOACTIVE CONTAMINATION
AT PROPERTY 1 ON LATTY AVENUE

Areas and depths of contamination on Property 1 are shown in Figure 3-3. Before remedial action begins, additional soil samples will be collected and analyzed from areas at which contamination boundaries need to be defined more accurately. The areas and depths of contamination shown in Figure 3-3 depict a conservative or over-estimate of contamination boundaries.

Radioactive contamination is present on all six Latty Avenue vicinity properties. Thorium-230 was identified as the major contaminant. Depths of contamination range from surface to 4.3 m (14 ft) at one location on Property 1. Typically, contamination is confined to the top 1 m (3 ft) of soil. In general, the areas of contamination are smaller and fewer with distance away from Latty Avenue.

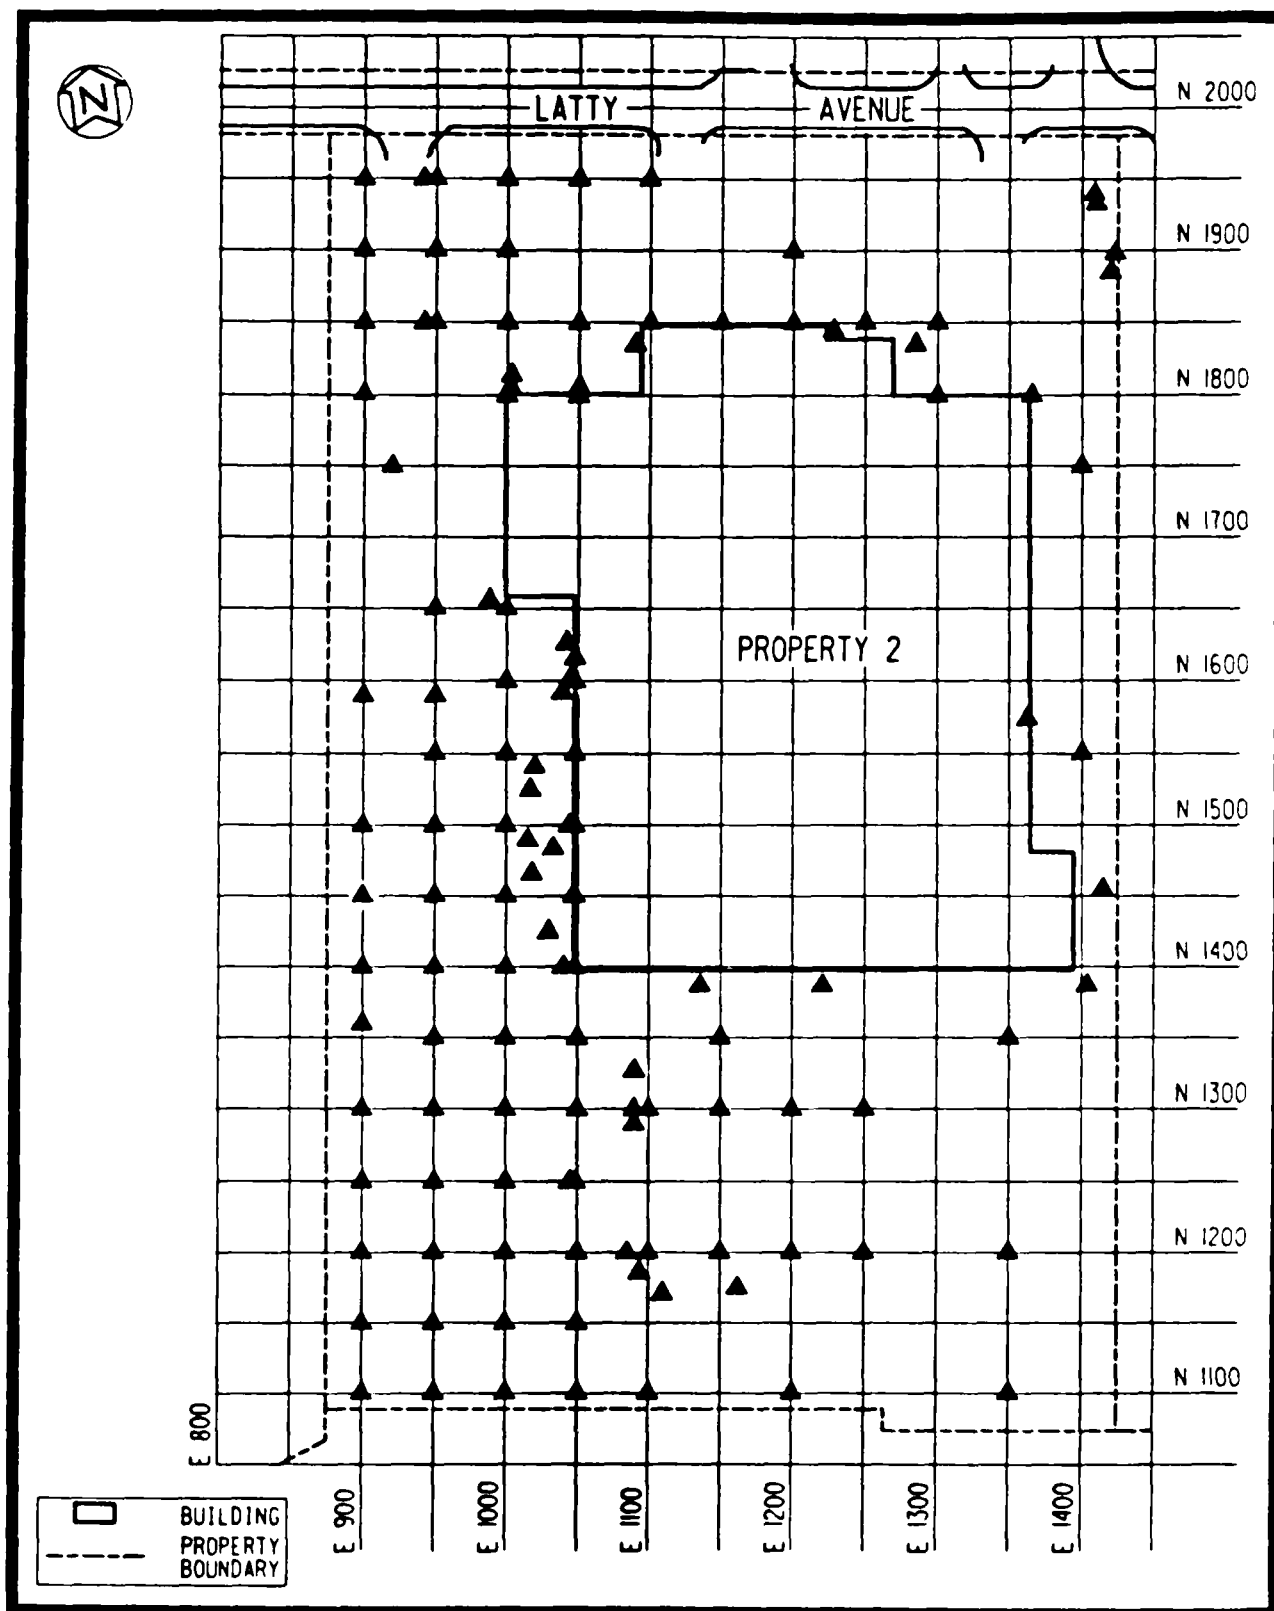
FIGURE 3-4 SURFACE SOIL SAMPLING LOCATIONS FOR
RADIOLOGICAL CHARACTERIZATION OF
PROPERTY 2 ON LATTY AVENUE

Soil sampling locations on Property 2 are shown in Figures 3-4 and 3-5. Analytical results for soil revealed areas with elevated concentrations of radium-226 and thorium-230 in surface and subsurface samples. Uranium-238 concentrations ranged from less than 3 to 100 pCi/g. Radium-226 concentrations ranged from 0.6 to 89 pCi/g. Thorium-232 concentrations ranged from 0.7 to 5 pCi/g. Concentrations of thorium-230 ranged from 0.4 to 5,700 pCi/g in the selected samples analyzed for thorium-230.

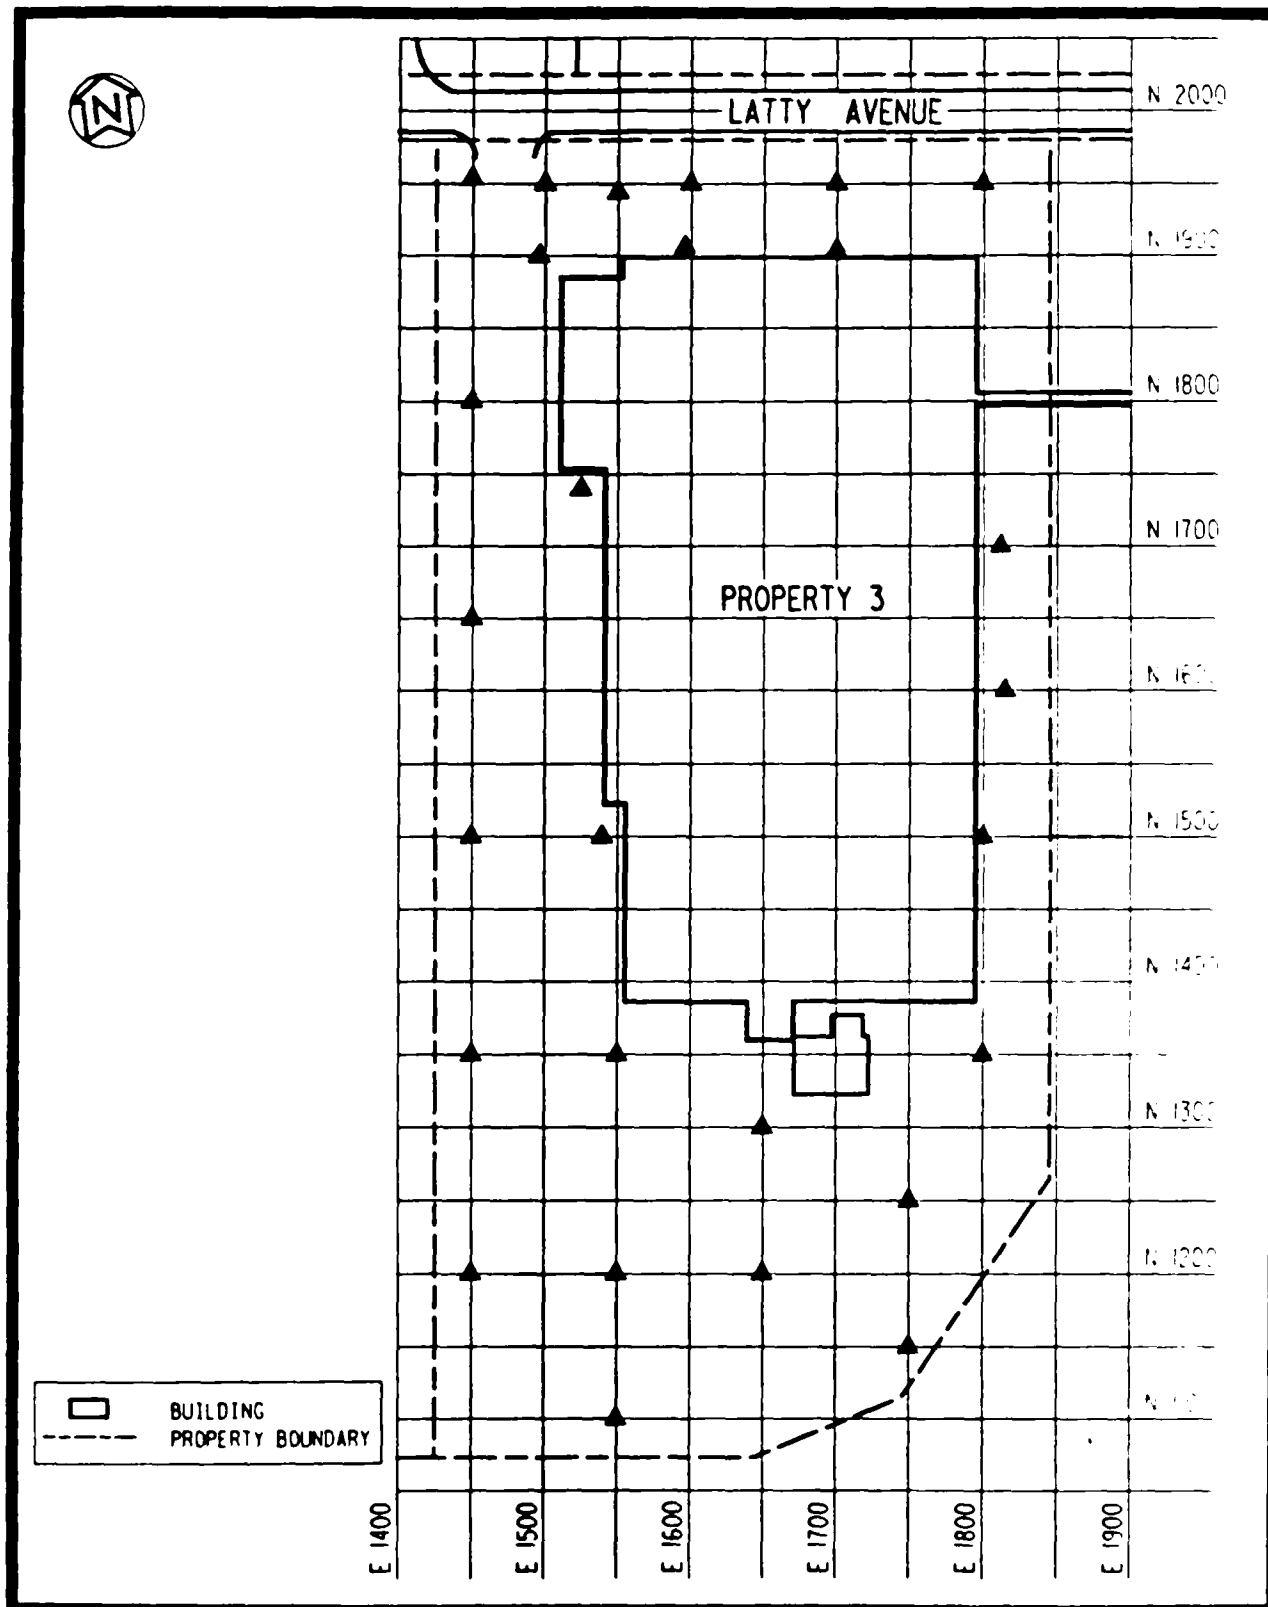
FIGURE 3-7 SURFACE SOIL SAMPLING LOCATIONS FOR
RADIOLOGICAL CHARACTERIZATION OF PROPERTY 3
ON LATTY AVENUE

Soil sampling locations on the Property 3 are shown in Figures 3-7 and 3-8. Analytical results for soil revealed areas with elevated concentrations of thorium-230 in surface and subsurface samples. All uranium-238 concentrations were less than 39 pCi/g. Radium-226 concentrations ranged from 0.6 to 4 pCi/g. Concentrations of thorium-232 ranged from less than 1 to 5 pCi/g. Thorium-230 concentrations ranged from 0.2 to 31 pCi/g.

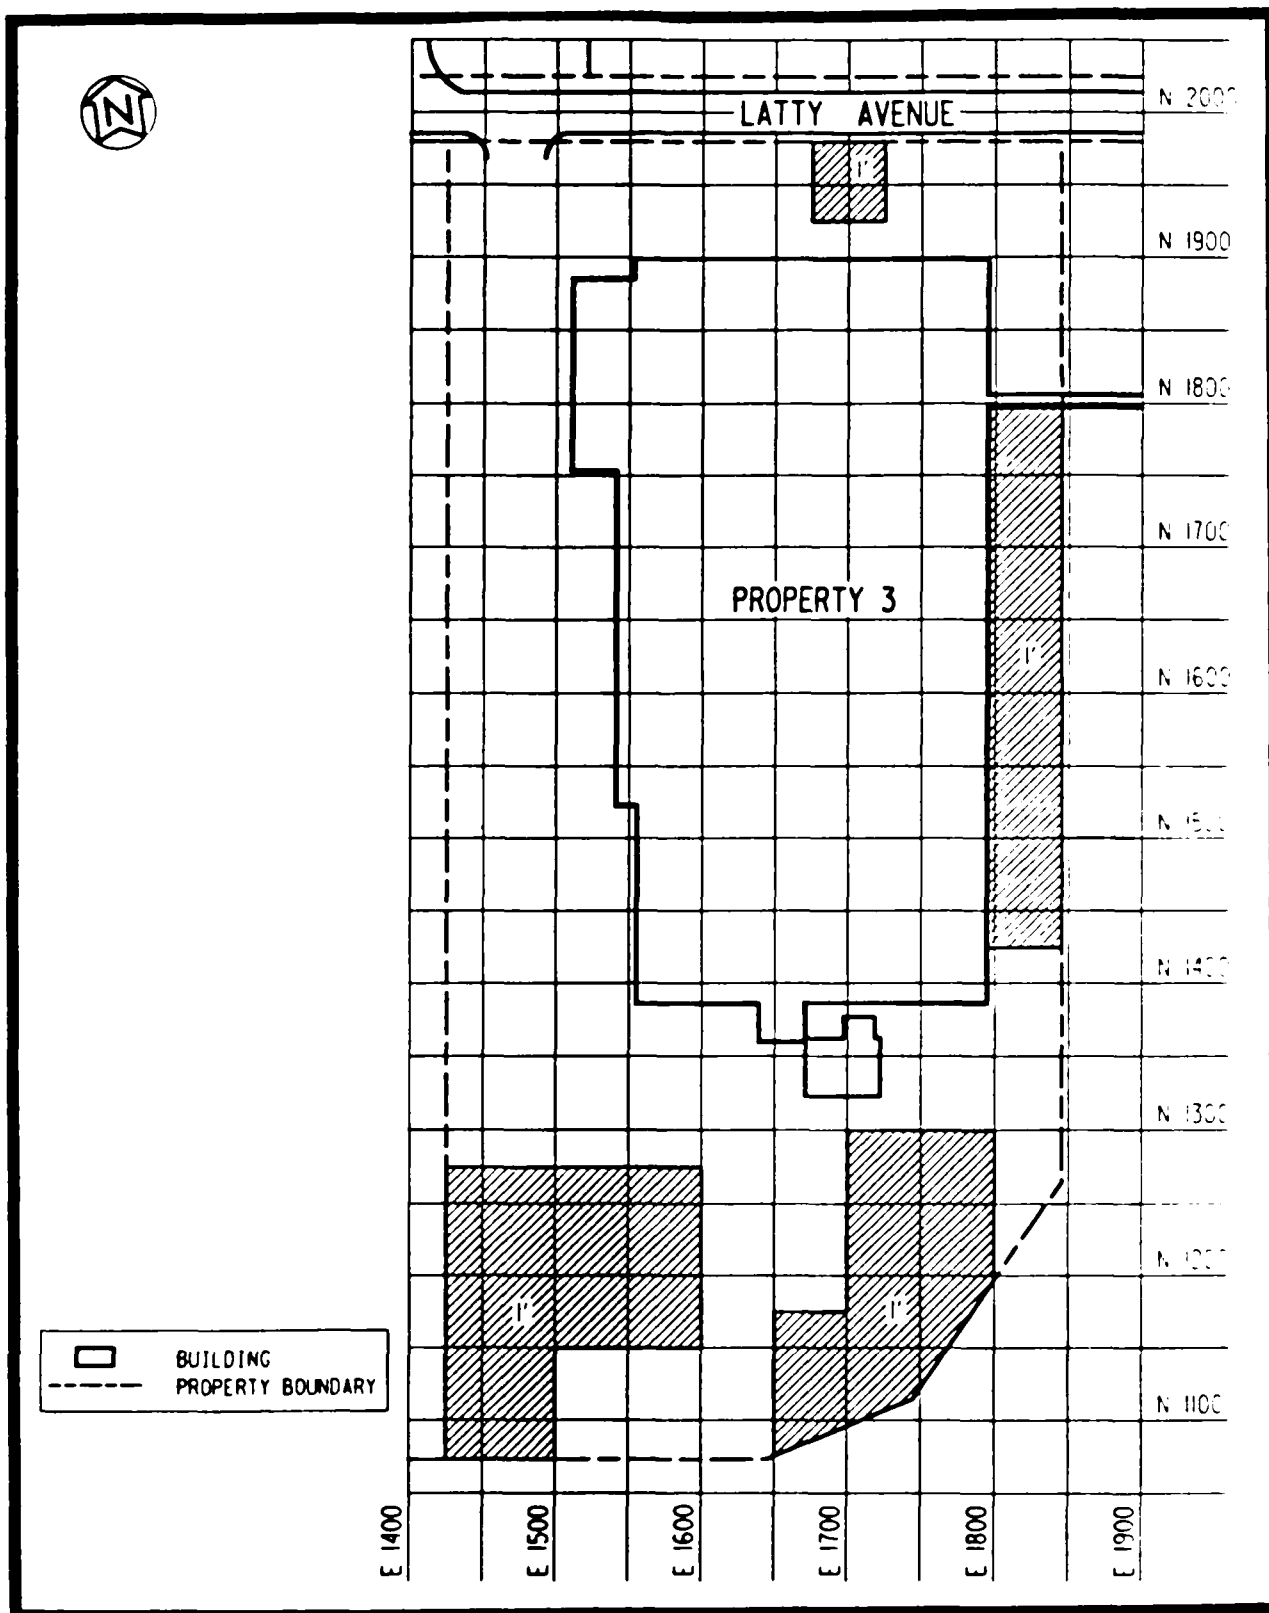
FIGURE 3-9 AREAS AND DEPTHS OF RADIOACTIVE CONTAMINATION AT PROPERTY 3 ON LATTY AVENUE

Analytical results for soil are provided in Table 3-6. Areas and depths of contamination on Property 3 are shown in Figure 3-9.

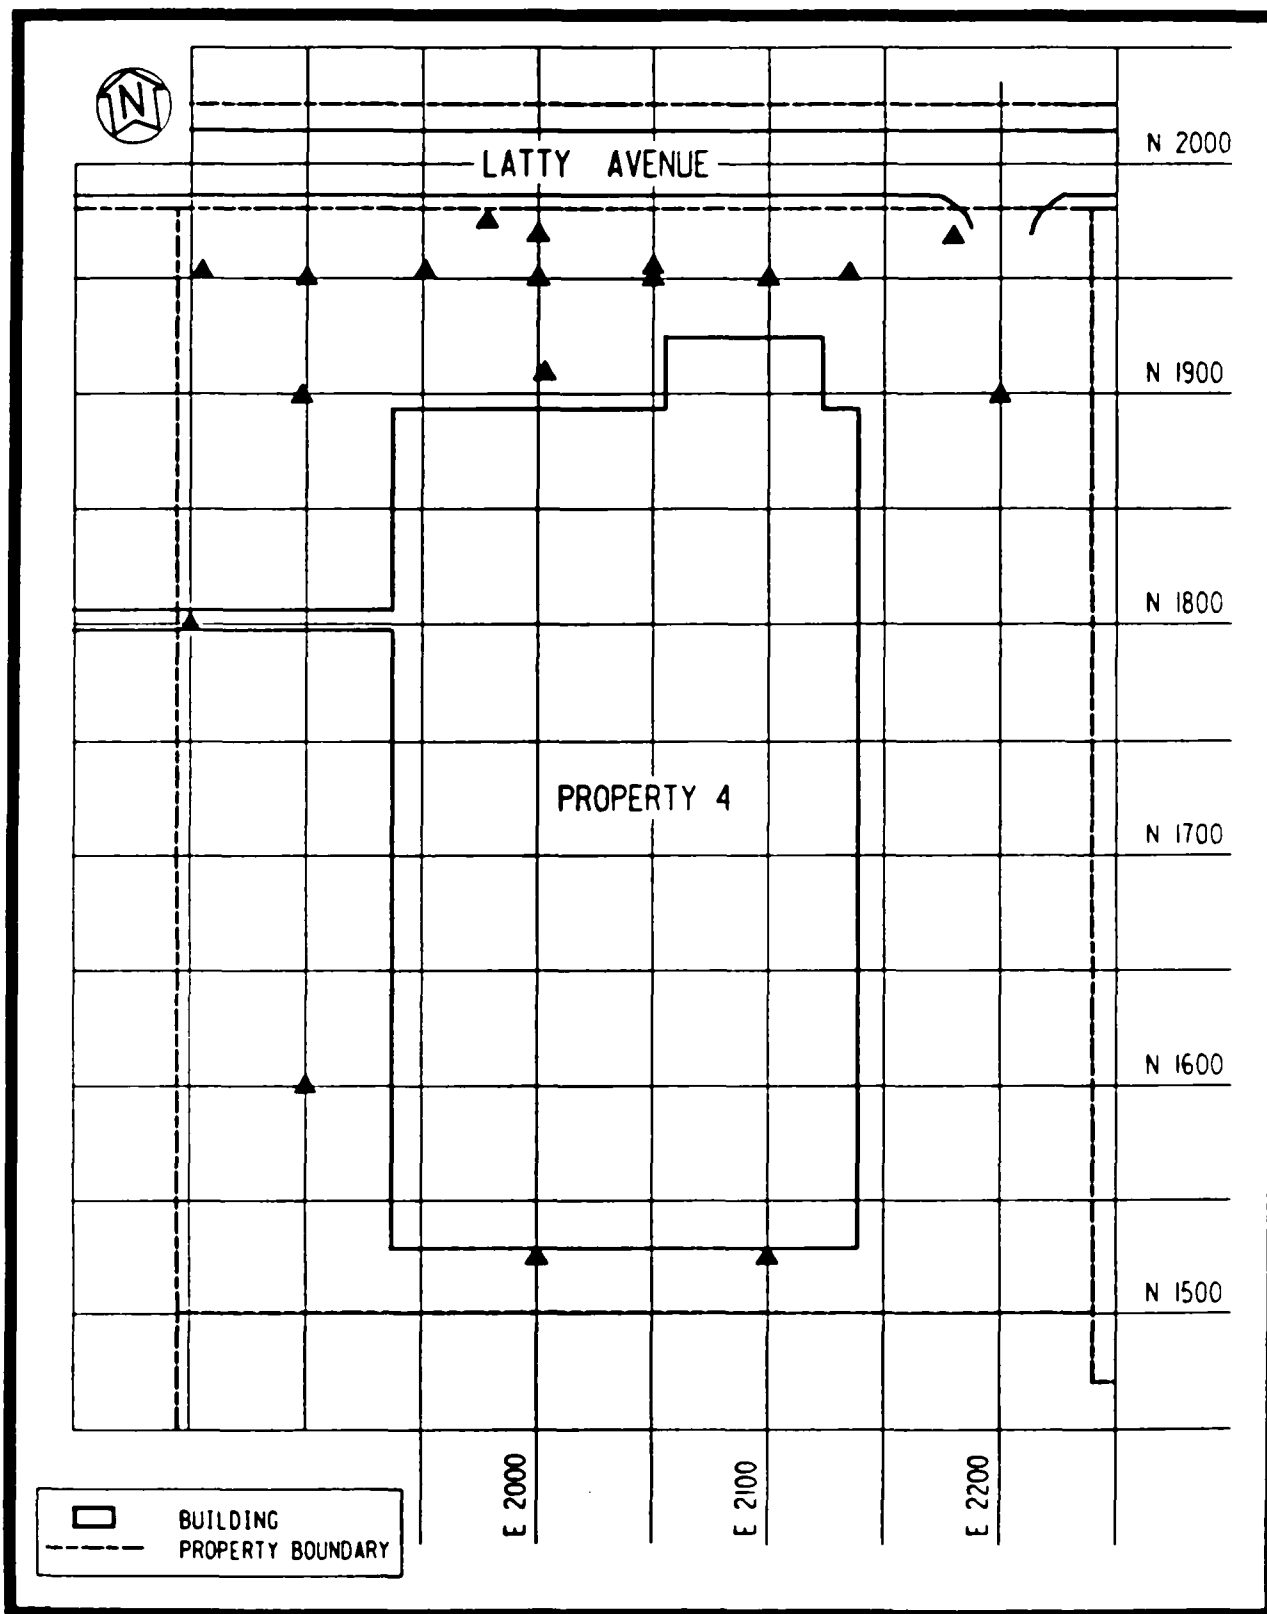
FIGURE 3-10 SURFACE SOIL SAMPLING LOCATIONS FOR RADIOLOGICAL CHARACTERIZATION OF THE PROPERTY 4 ON LATTY AVENUE

Soil sampling locations on Property 4 are shown in Figures 3-10 and 3-11. Analytical results for soil (Table 3-8) revealed areas with elevated concentrations of radium-226 and thorium-230 in surface and subsurface samples. All uranium-238 concentrations were less than 20 pCi/g. Radium-226 concentrations ranged from 0.5 to 10 pCi/g. Thorium-232 concentrations ranged from 0.5 to 4 pCi/g, and thorium-230 concentrations ranged from 0.7 to 460 pCi/g.

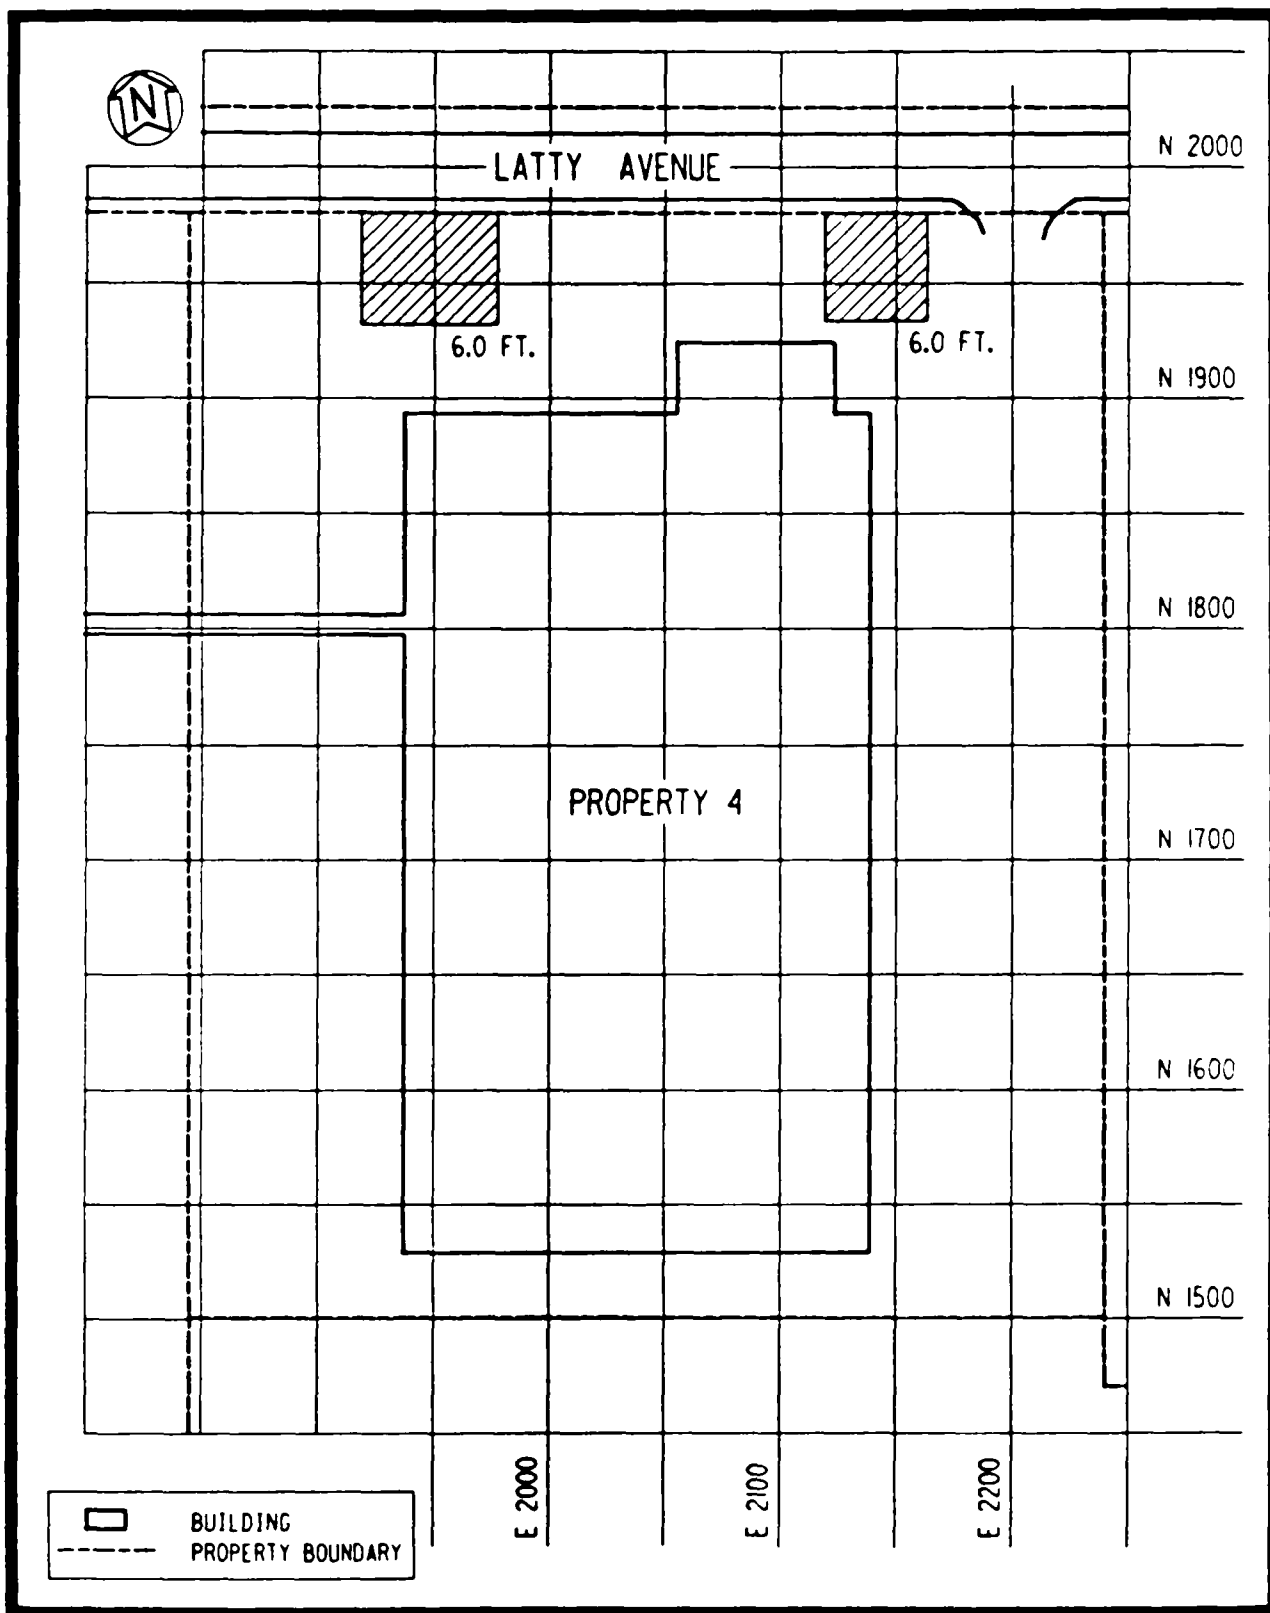
FIGURE 3-12 AREAS AND DEPTHS OF RADIOACTIVE CONTAMINATION AT PROPERTY 4 ON LATTY AVENUE

The areas and depths of radioactive contamination on Property 4 are shown in Figure 3-12.

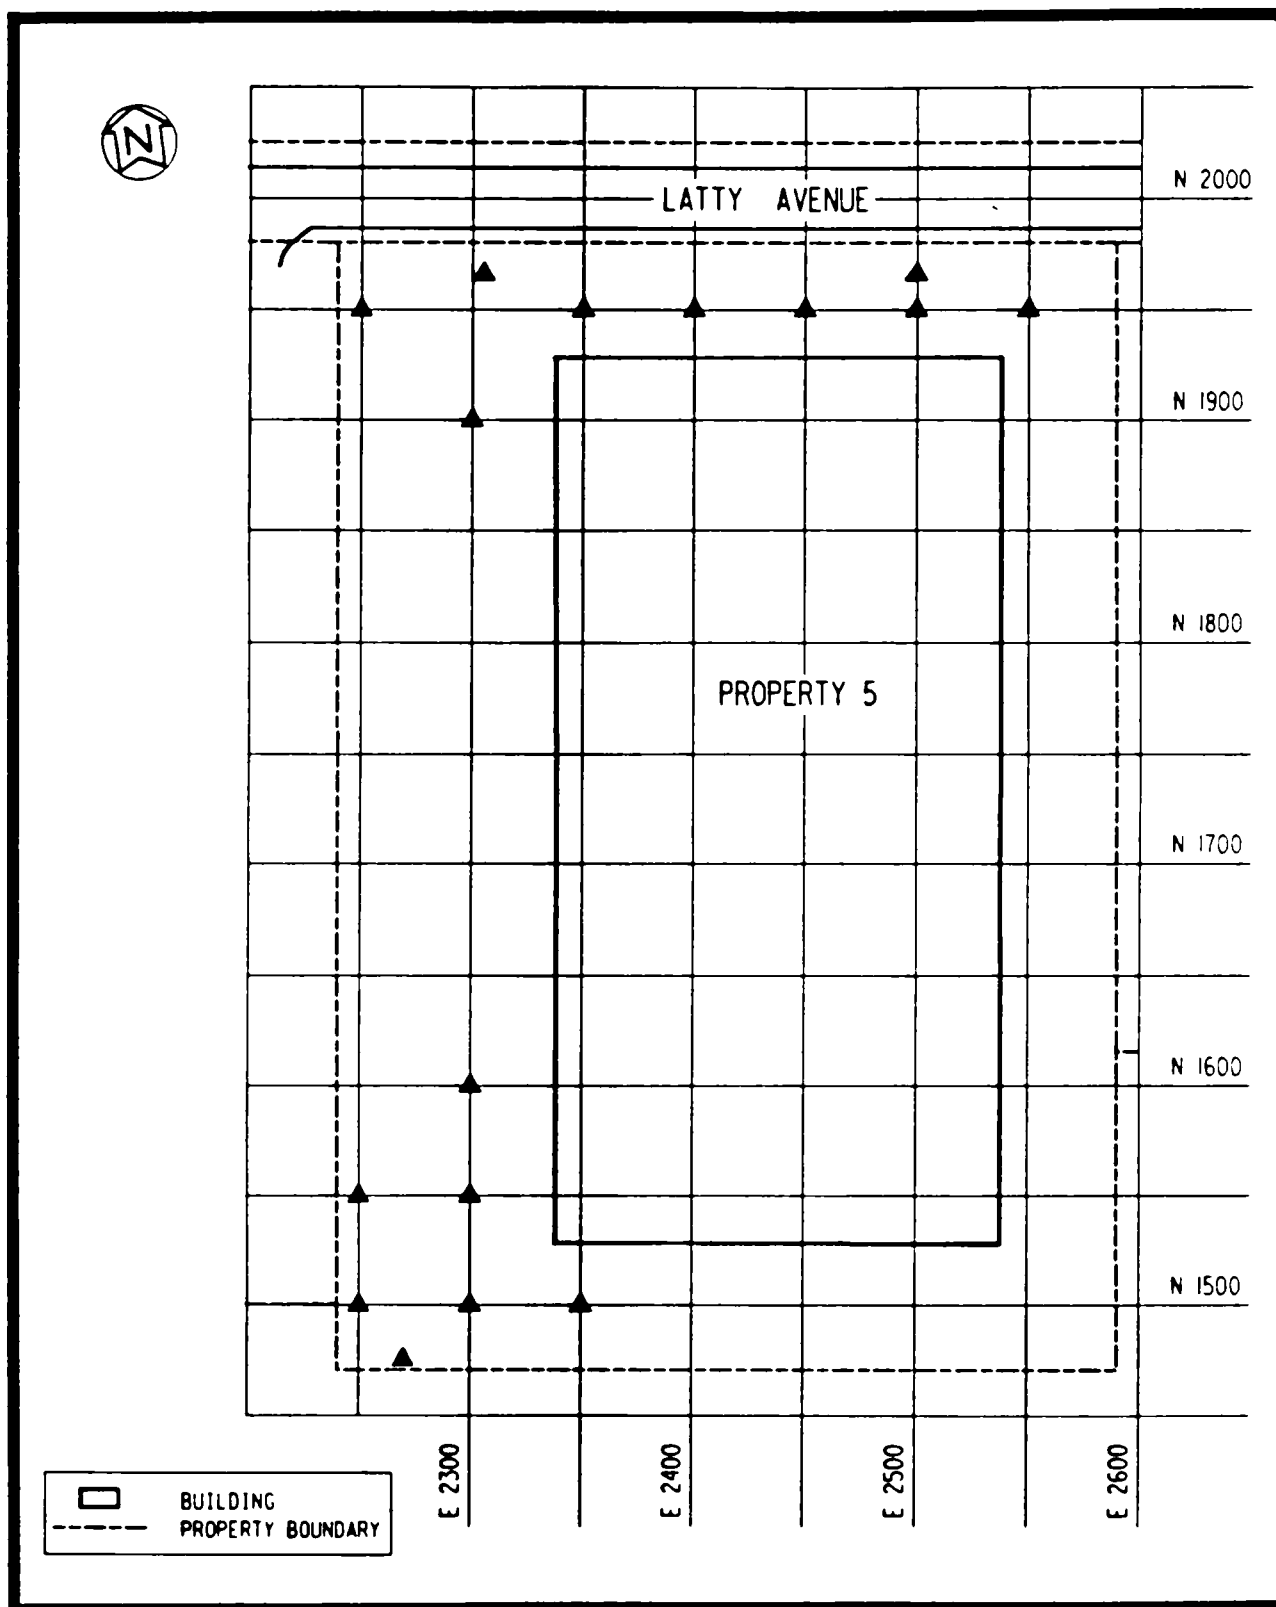
FIGURE 3-13 SURFACE SOIL SAMPLING LOCATIONS FOR
RADIOLOGICAL CHARACTERIZATION OF
PROPERTY 5 ON LATTY AVENUE

Soil sampling locations on Property 5 are shown in Figures 3-13 and 3-14. Analytical results for soil (Table 3-10) revealed areas with elevated concentrations of thorium-230 in surface samples. All uranium-238 concentrations were less than 30 pCi/g. Radium-226 concentrations ranged from 0.7 to 4 pCi/g. Concentrations of thorium-232 ranged from 0.8 to 7 pCi/g. Thorium-230 concentrations ranged from 0.6 to 12 pCi/g. Areas and depths of contamination on Property 5 are shown in Figure 3-15.

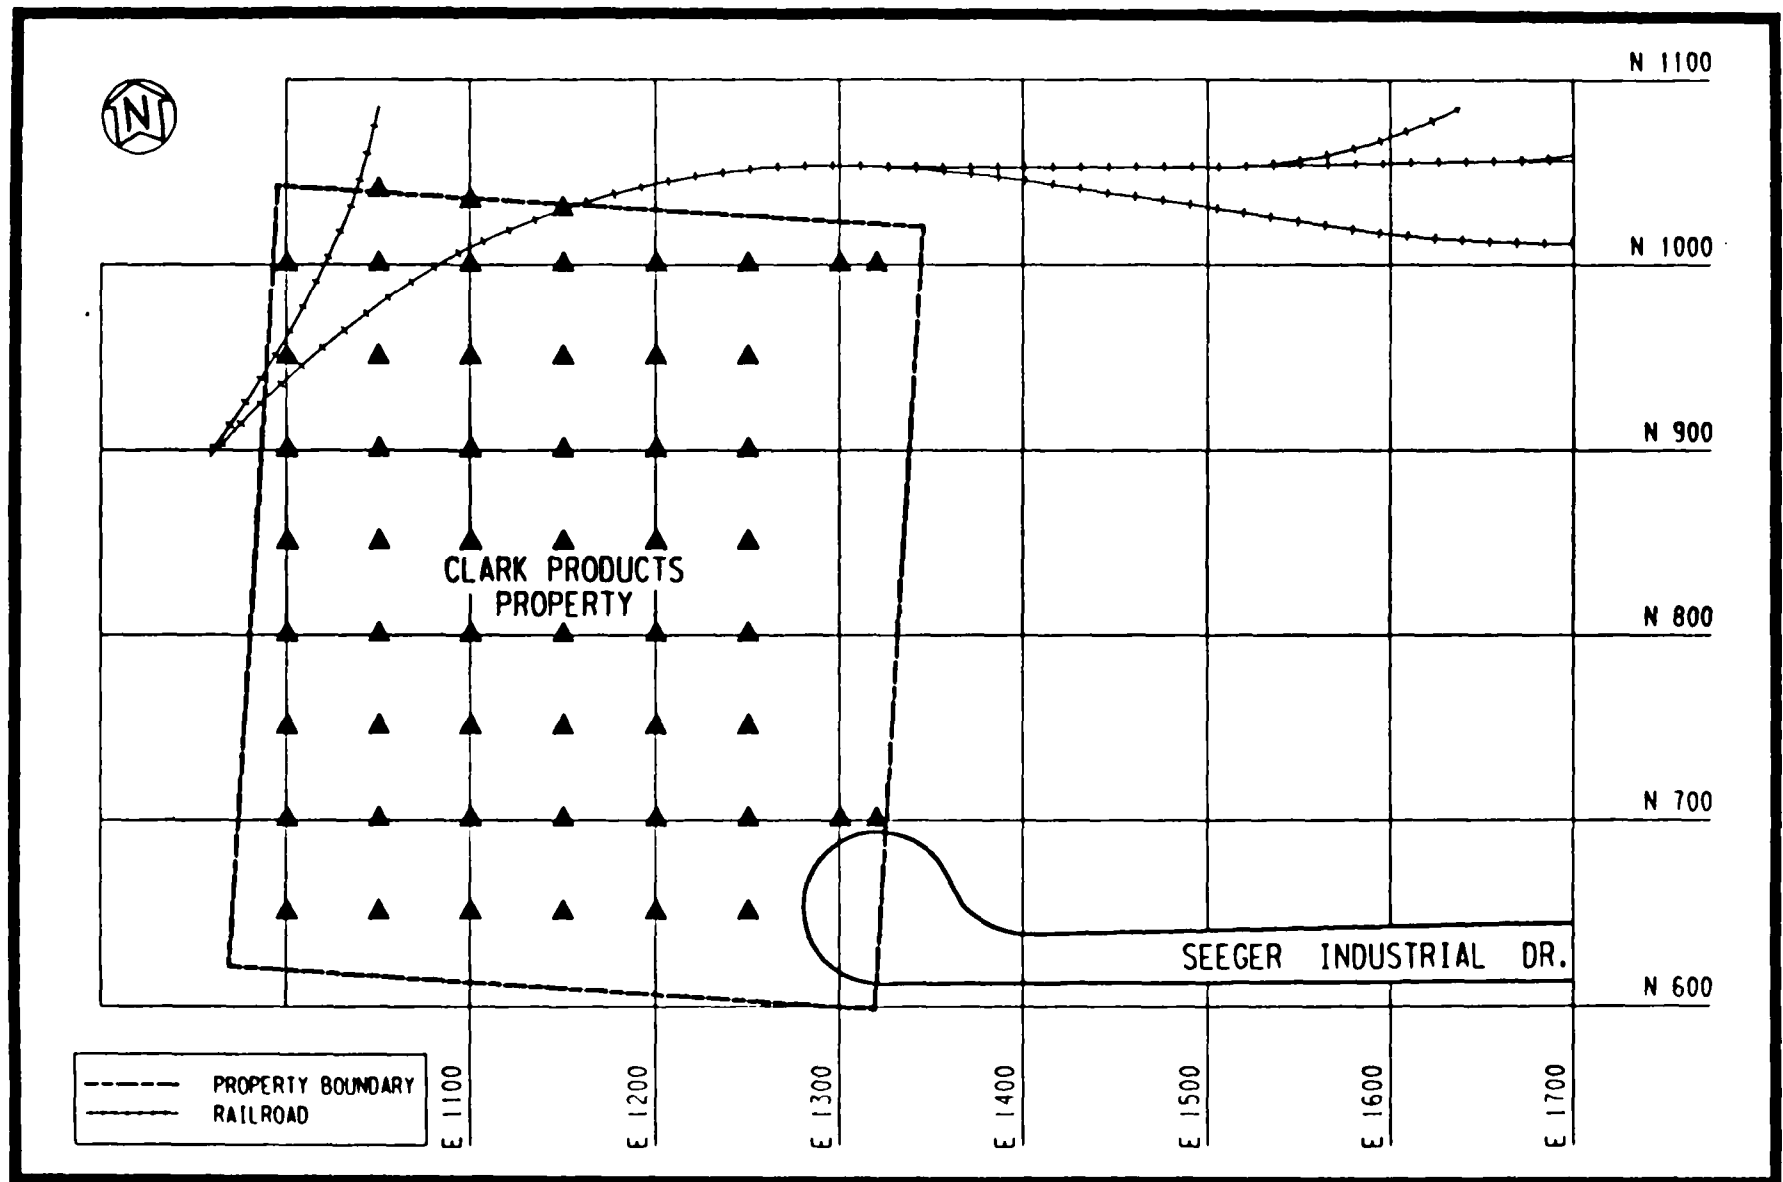
FIGURE 3-16 SURFACE SOIL SAMPLING LOCATIONS FOR PROPERTY 6
ON SEEGER INDUSTRIAL DRIVE

Surface soil sampling locations on this property are shown in Figure 3-16, and subsurface soil sampling locations are shown in Figure 3-17. Analytical results for soil (Table 3-12) revealed areas with elevated concentrations of thorium-230 in surface

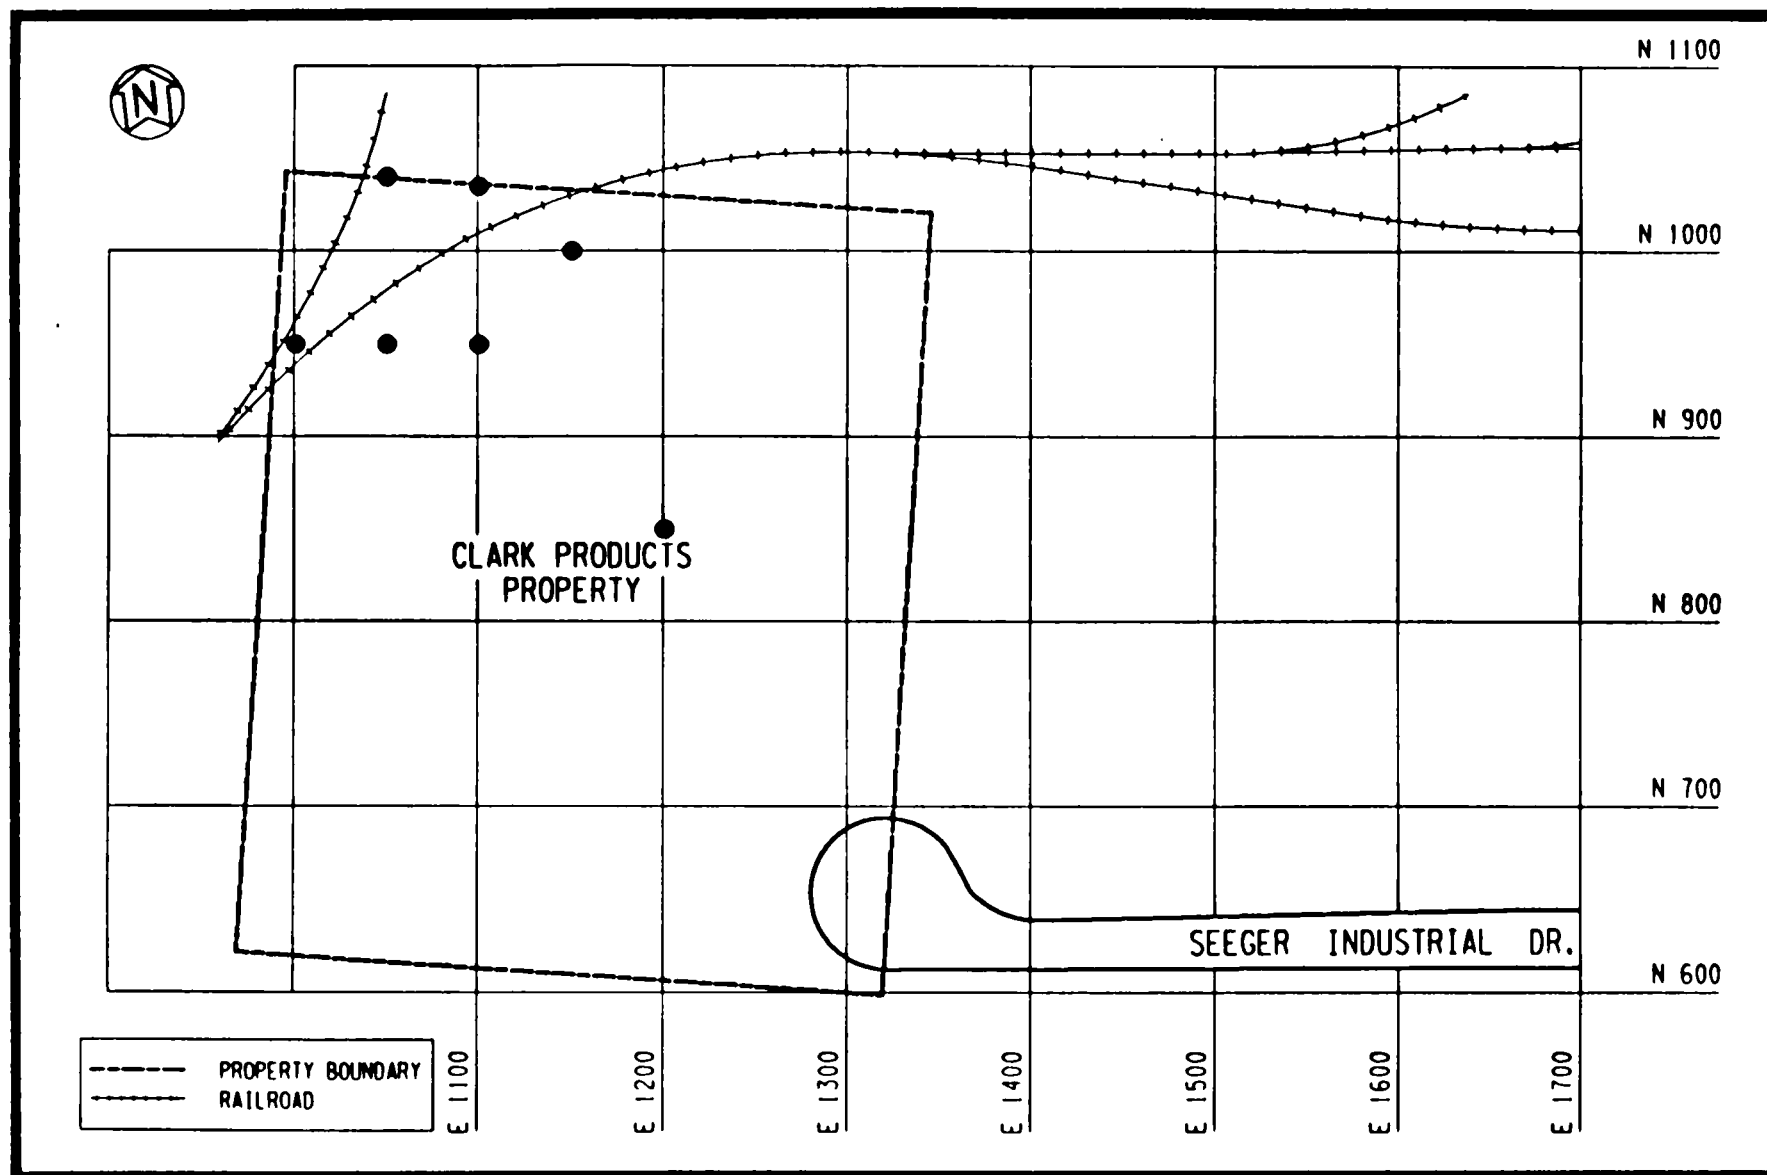
FIGURE 3-17 SUBSURFACE SOIL SAMPLING LOCATIONS FOR RADIOLOGICAL CHARACTERIZATION OF PROPERTY 6 ON SEEGER INDUSTRIAL DRIVE

samples. All uranium-238 concentrations were below 14 pCi/g. Radium-226 concentrations ranged from 0.4 to 3 pCi/g. Concentrations of thorium-232 and thorium-230 ranged from 0.8 to 4 pCi/g and less than 0.7 to 21 pCi/g, respectively. Further soil sampling is required at Property 6 before the boundaries of radioactive contamination can be determined. This sampling will occur prior to remedial action.
